ANOTHER PROBLEM SOLVED!

INSTRUMENTATION FAILURE CAUSED BY SEASONAL VARIATIONS OF COMPRESSED AIR DEWPOINT

STEEL MANUFACTURING | INSTRUMENTATION AIR ENERGY EFFICIENT HEATLESS DRYER

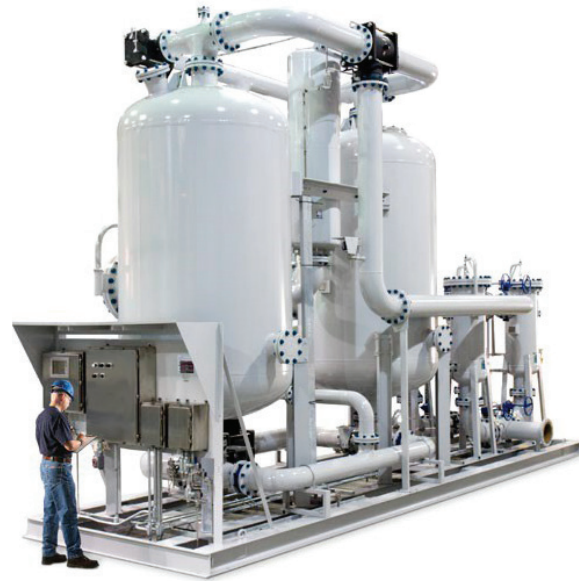
- Heatless Dryer
- 2500CHA complete with Pre and After Filter
- 15% Compressed Air Purge Rate
- Highest Design Reliability
- Longest Desiccant Life Design
- ADC Advanced Dryer Controls Monitor Moisture Load to Maximize Purge Loss
- Heatless Dryer Technology can be modified to Heat Reactivated eliminating Purge and Preventing the need to purchase additional Compressors

- Compressed Saturated Air Enters the Dryer and -40° F Dewpoint Air Exits
- 15% Purge Rate (Back Wash)
- -40° F Dewpoint Purge @ 100 PSI Expanded to 0 PSI Converts to -70° F Dewpoint
- -70° F Dewpoint Purge Air is Drier than Moisture Content on Desiccant and therefore Desiccant Regeneration takes place
