Custom Solutions Bulletin

Industry: Marine - Shipbuilding

Application: Personnel Protection

Product Description: Blow-off cover for a spiral nozzle with a

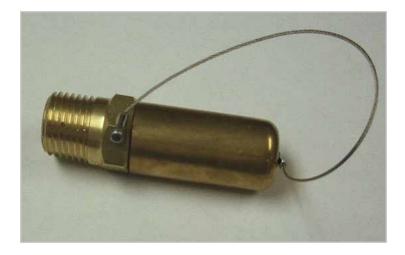
BETE's solution: The BETE Applications Engineer's knowledge of the entire product line enabled him to suggest a blow-off cover attached to a lanyard, similar in arrangement to that available on the N series spiral nozzles. In this arrangement, a cylindrical cover is fitted over the spiral section of the nozzle and is held in place via compression of an o-ring. The cover is attached via a short cable to the nozzle body. When the system is activated, the force of the water flowing through the nozzle blows the cover off, allowing the spray pattern to develop normally. The lanyard keeps the cover attached to the nozzle body so that it can be replaced onto the nozzle after the system is deactivated. BETE Design Engineers modified the body of the desired nozzle to allow for the o-ring that keeps the cover in place. Also, the specific nozzle has a long, narrow body, which created an issue with how to economically manufacture the covers. After researching and experimenting with various techniques a method was developed that allowed BETE to provide the nozzle the customer specified with the cover, eliminating the safety hazard while still allowing normal function of the nozzle.
